ASSESSMENT OF REINFORCING STEELS IN CONCRETE EXPOSED TO SALINATION WATER BY USING NDT (HALF-CELL POTENTIAL)

Abdul Aziz Mohamed¹, Mohd Izwan¹, Pauzi Ismail² and Zainudin Yahya¹

¹Centre for Nuclear Energy, College of Engineering, Universiti Tenaga Nasional (Uniten),
43000 Kajang, Selangor, Malaysia.

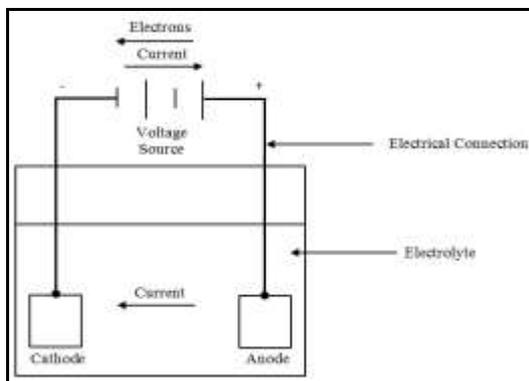
Figure 1. Schematic of a corrosion cell

Corrosive activity can occur in metal substances mainly through an electrochemical process (M. Daud *et al.*, 2013). In order for this corrosion circumstances to occur, a complete electrical circuit must exist as in Figure 1.

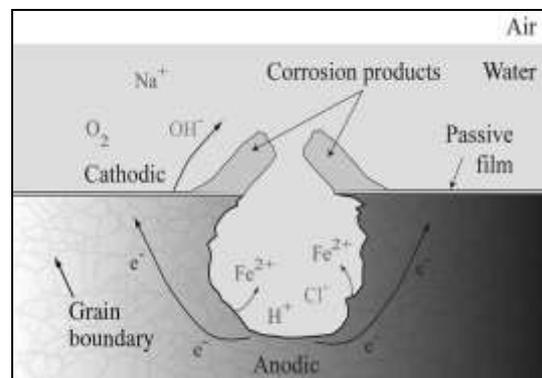
Figure 2. Corrosion processes on the steel surface (Fontana M.G., 1986)

The corrosion process actually involves two separate, but coupled chemical reactions that take place simultaneously at two different sites of the steel surface. An electric current must flow in a closed loop between the two sites for the reactions to proceed. In corrosion, the two-electrochemical reactions are known as ‘anodic’ and ‘cathodic’ reactions, respectively, and the areas on which they occur in the steel are called ‘anodic’ and ‘cathodic’ areas or simply anodes and cathodes as in Figure 2.

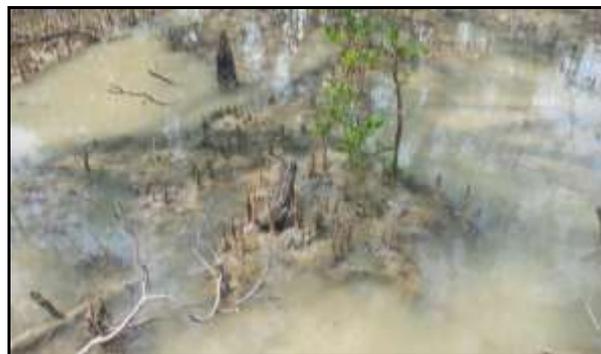
Figure 5. The actual environment for Salt marsh water

salt marsh that are suitable for study. Figure 4 highlights the location of the water source whilst Figure 5 shows the actual nature of the location.

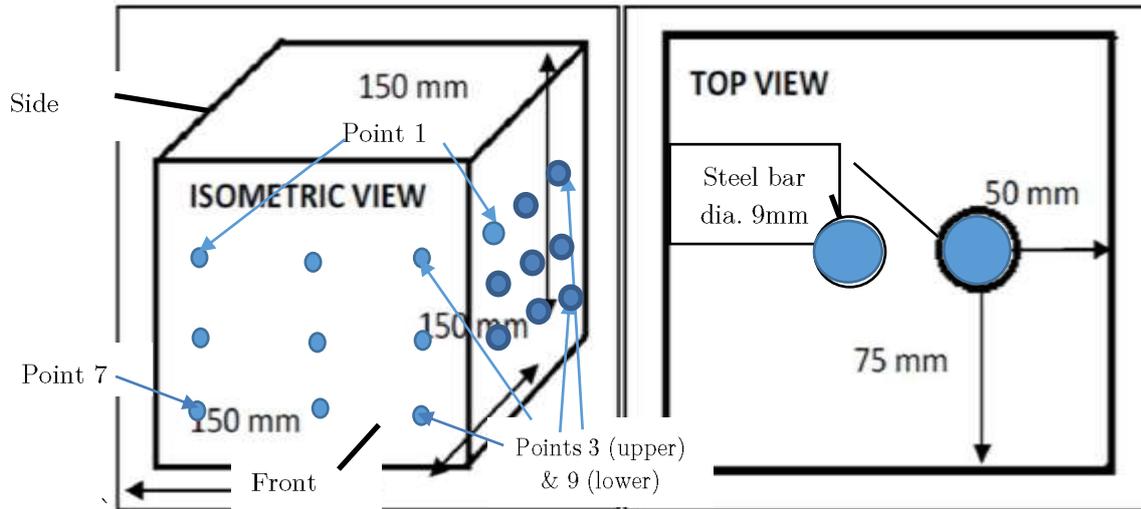
Figure 7. Concrete cube dimensions for testing purposes; points of half-cell probe measurement are indicated

There are various type of concrete grade for industrial use, however for this experiment the selection of concrete were to be specified as grade 25. Concrete mixture is crucial in civil engineering aspect as it determines the total strength of specific structure. Standardization was set in order to segregate the application of that particular grade on industrial scale. Table 2 shows the mixture and usage of several grade of concrete and its usage. The selection of concrete grade in this study was the G25. Using this grade the concrete cube were created to simulate the behavior of the particular concrete in other forms of environment using all 4 types of water sample. The measurement of concrete cube is as highlighted in Figure 7.

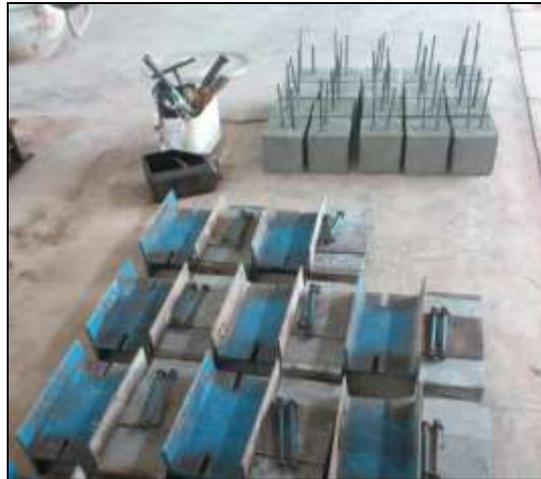
Figure 8. Actual concrete samples ready for experiment

The sample between mild steel rebar considered complete once the rebar were submersed into the half hard concrete. The complete sample that ready to be used for experiment purposes is shown in Figure 8.

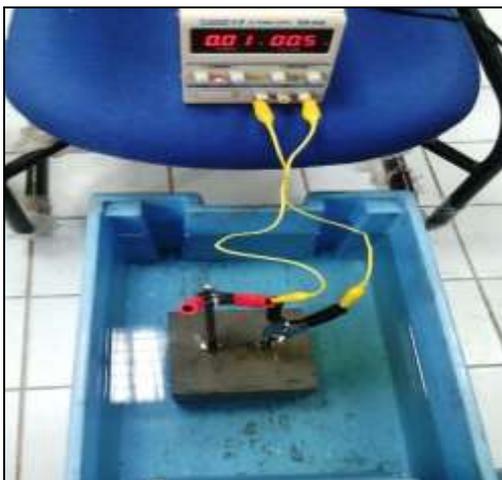
Figure 9. Actual setup for DC supply for simulating the corrosion process

Simulation of corrosion were made using a direct current (DC) applied on both rebars where one connected to anode and the other connected to cathode. The test was carried out by submersing the concrete cube to the test waters which is acted as an electrolyte. The set-up of the corrosion simulation is shown in Figure 9. The effective voltage for accelerating the corrosion process was 0.09 Volts. After running the DC current testing, specimens were dried for one day. To stimulate back the corrosion particle, the concrete cubes were dipped into carboxylic acid solution in the form of soap water as per Figure 10.

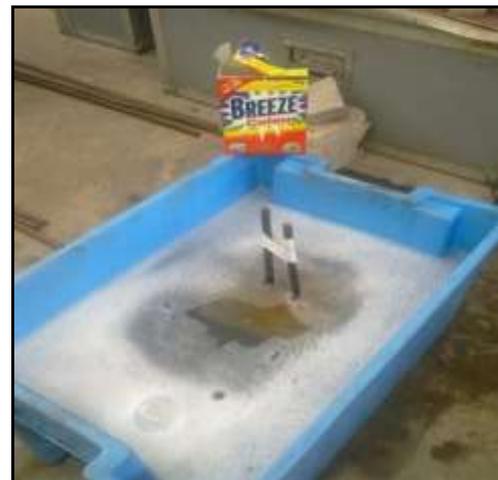
Figure 10. Concrete cubes dipped into carboxylic acid solution to stimulate the corrosion particle for half-cell analysis

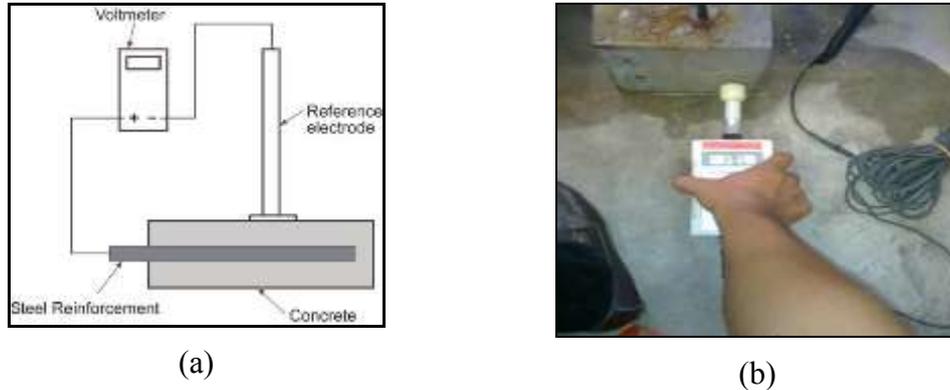
Figure 9. (a) Schematic diagram of half-cell potential measurement technique [7] and (b) Actual half-cell potential measurement using the reference electrode

The half-cell potential measurement was used in this study. It is an electrochemical technique commonly used by engineers to assess the severity of corrosion in reinforced concrete structures. The normal conceptual of this measurement is using copper/copper sulphate (Cu/CuSO₄) as reference electrode and placed on the surface of the concrete with the steel reinforcement underneath (Salihu Andaa Yunusa, 2011). The schematic diagram of the method is shown in Figure 9.

From Figure 9, the reference electrode is connected to the negative end of the voltmeter and the steel reinforcement to the positive, refer to Figure 9(a). This method is found to be a success for the case of bridge deck corrosion surveys thus formed the basis of the ASTM standard of C876 that provides general guidelines for evaluating corrosion in concrete structures (Ping Gu *et al.*, 1998). Points of measurement as indicated in Figure 7. Figure 9(b) shows the placement of reference electrode to the concrete surface.

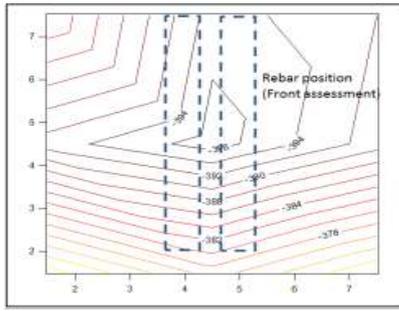
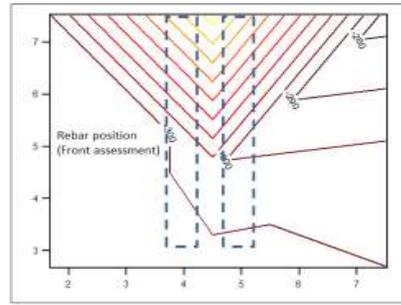
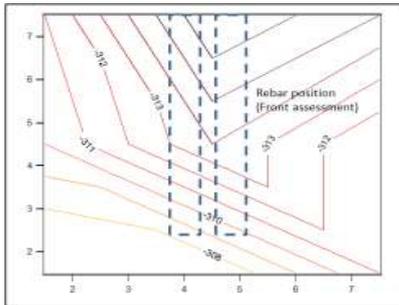
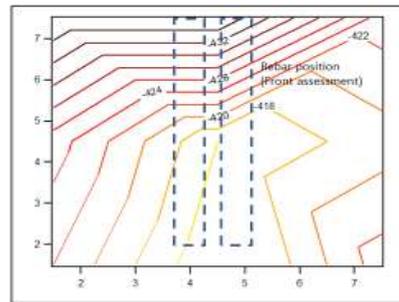
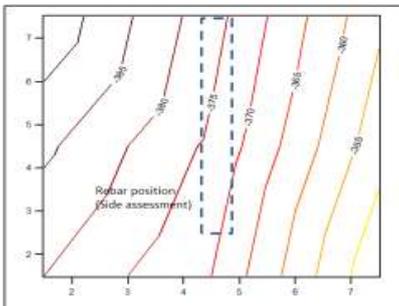
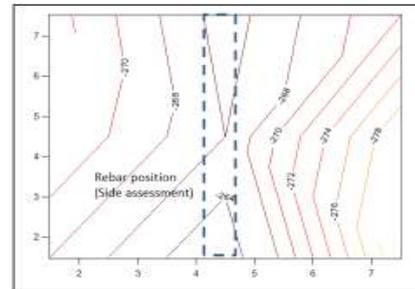
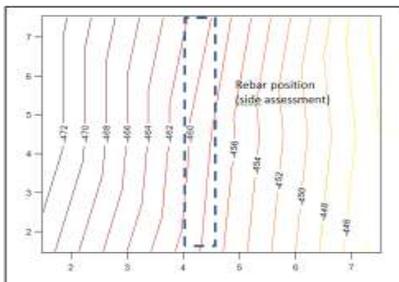
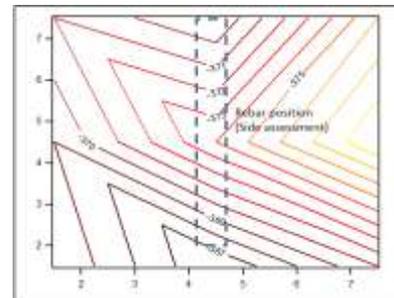
Figure 10. The half-cell measurement between the sea water and other water which is the most severe corrosion occurred; (a) 2 hours, (b). 4 hours, (c) 6 hours and (d) 8 hours

The following figures show some results on the half-cell measurement between the sea water and other water which is the most severe corrosion occurred studied in this work, see Figure 10. In this work, the level of corrosion currents and the degree of corrosivity of the steels are based on the ASTM criteria as shown in Table 4.

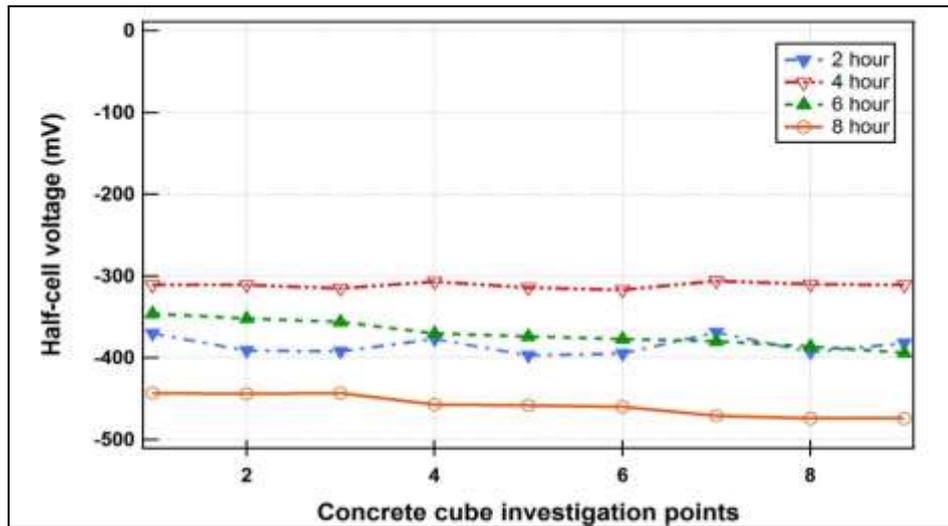
Figure 11. Half-cell voltage measurement on concrete cube investigation points for sea water analysis with different hours under the exposure of DC current.

Based on Figure 11, the result for 4 hours contributes lesser mV as compared to 2 hours of exposure. This can be due to the porosity of the concrete cube. Even though similar process implemented during the mixture of concrete, however the uniformity of the concrete still varies among all cubes. The corrosion of 2 hours were supposed to occur on the surface of the concrete as per 4 hours results, however, the middle part of the concrete leads to higher corrosion potential. This means that the electrolysis circuit that leads to corrosion completes for 2 hours test specimen due to porosity of the middle part of the concrete. For 6 and 8 hours of exposure, the pattern was as expected.

Sea water did provide with some abnormal results with the early assumptions as the longer exposure of DC current towards the rebar, the percentage of corrosion will increase simultaneously. This assumption is not true for sea water experiment due to the 2 hours exposure of DC leads to higher value of mV as compared to 4 hours.

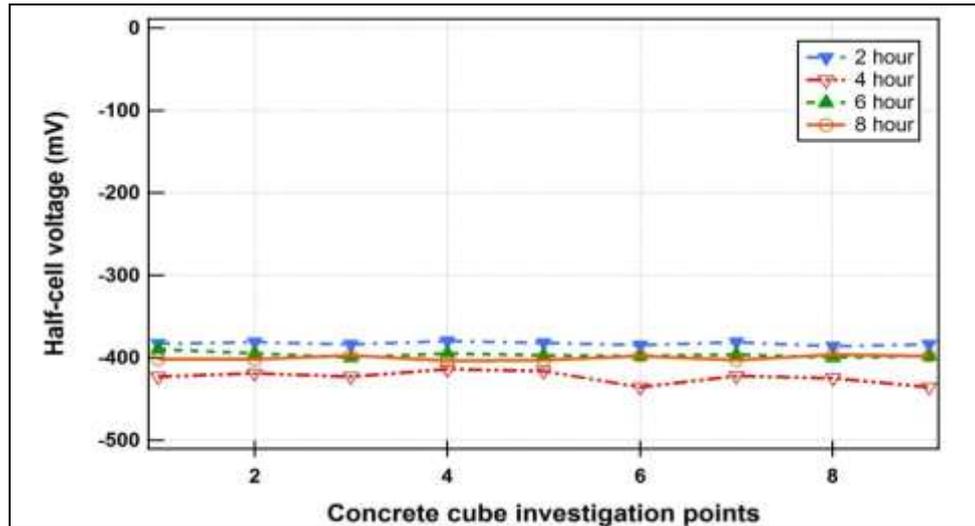
Figure 12. Half-cell voltage measurement on concrete cube investigation points for salt marsh water analysis with different hours under the exposure of DC current.

Figure 12 shows the irregularities on data profiles for 4 hours of exposure. As we know, the salt marsh also has the presence of salt in its content and can boost up the corrosion potential value. It is shown that the highest potential of corrosion occur at top surface of the concrete which is justified because the area of rebar exposure is high on the top surface. This phenomenon is unexplainable since the procedure of experiment is standard between all specimens.

Irregularities also detected for salt marsh water results as 4 hour of DC exposure leads more mV value compared to 6 hours to 8 hours. Major fluctuation also detected for 4 hours data.

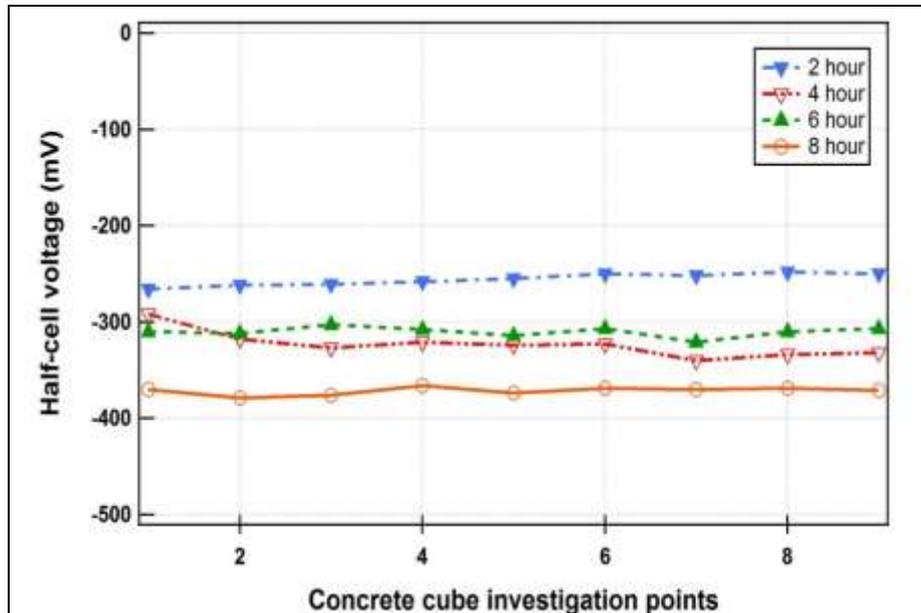
Figure 13. Half-cell voltage measurement on concrete cube investigation points for river water analysis with different hours under the exposure of DC current.

The pattern of corrosion potential for river water data as per Figure 13 is quite as expected and merge with the initial assumption which is as the longer exposure of test specimen towards DC current more corrode the rebar will be. However, the porosity issue can also be the contributing factor of the curve for 4 hours exposure is more than 6 hour. The potential of corrosion is high on the right side of the cube, thus the concrete is less uniform on the left side of the cube.

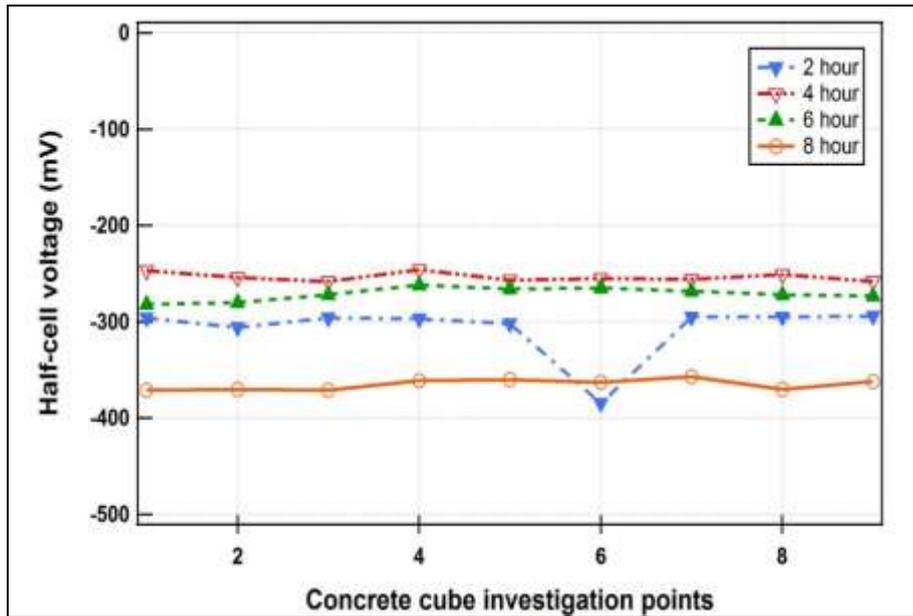
Figure 14. Half-cell voltage measurement on concrete cube investigation points for tap water analysis with different hours under the exposure of DC current.

Irregularities also occur for tap water result as per Figure 14 which the arrangement between 2 hour, 4 hour and 6 hour is not based on the initial assumption. However the values that fluctuate between these 3 results is on the range of intermediate corrosion potential, therefore the result variation is not a big different. However the sudden fluctuation do occur for 2 hours result which is at point 6 located on the middle right of the concrete cube. There may be some error on the reading because point 3 and point 9 which located also on the right side of the cube provides with almost similar but lower values of mV.
